Survey No. T-824

The Tom Faulkner house is the first house from the water on the west side of the Fairbank Road in the village of Fairbank on Tilghman Island, Talbot County, Maryland. The two-and-a-half story frame house faces east with the principal gable oriented on an east/west axis.

T-824  
Tom Faulkner House  
Tilghman Island Quadrangle

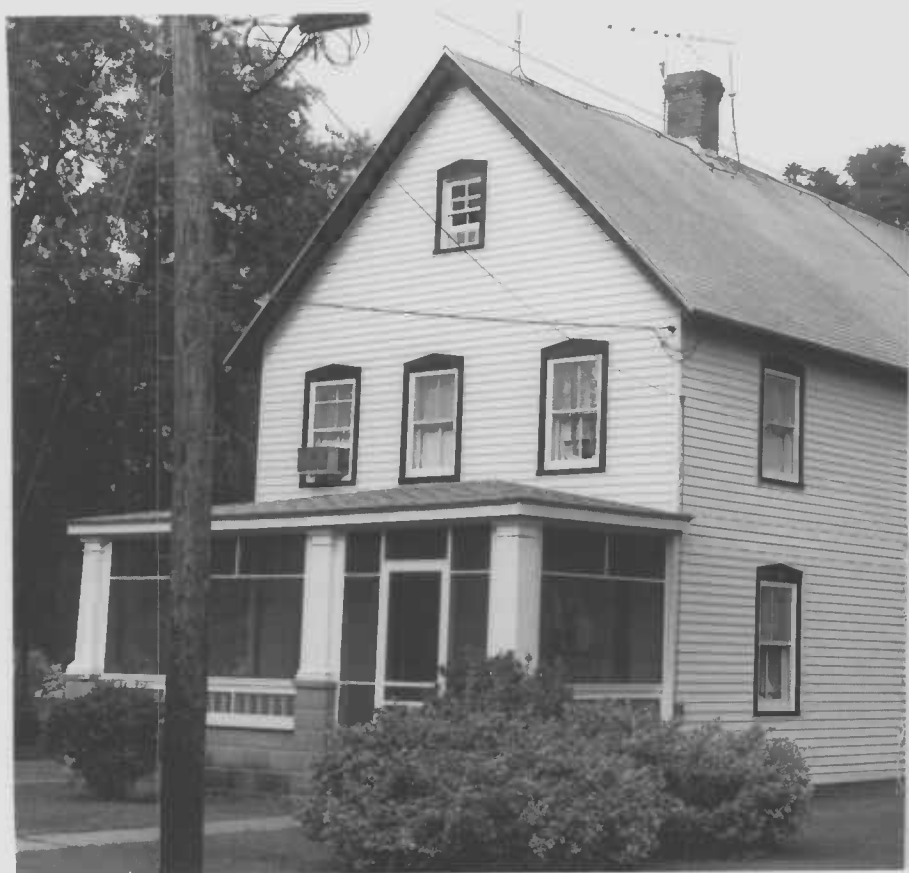
T-824

The east (main) facade of this three bay house is symmetrical although the northern bay is spaced more widely from the southern bays. A screened-in porch extends across the full width of the first floor which is supported by molded stone piers and square wooden columns with tapered sides. The sidelighted front door has a divided pane transom light, and acts as the house's northern bay. Two two-over-two sash windows with wide surrounds and peaked crown mouldings light the first floor. Three of these two-over-two sash windows light the second floor and a smaller two-over-two sash window with the same surround is inset into the attic story.

The two bays of the original north elevation are marked by two-over-two sash windows. The north side of the rear addition is arranged asymmetrically with one two-over-two sash window on both the first and second floors.

NORTH-EAST ELEVATION
